# MH370 – Search and debris examination update

**ATSB Transport Safety Report**

AE-2014-054

2 November 2016

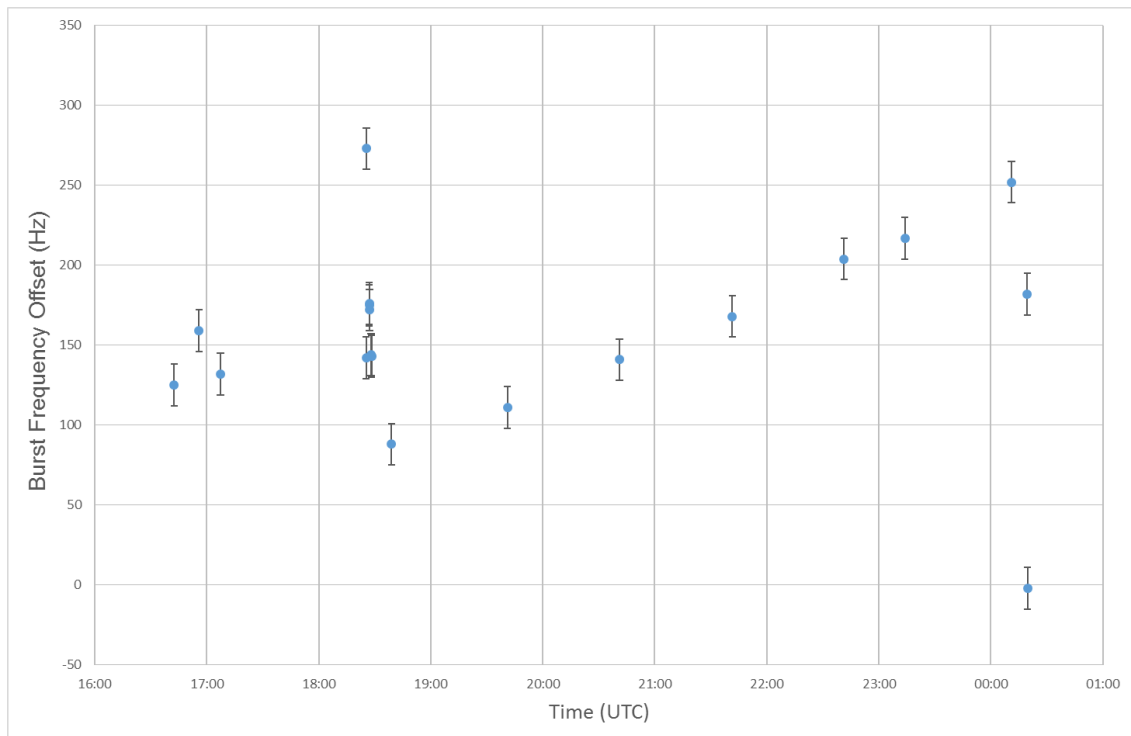
**Figure 1: Recorded BFO values throughout the flight**

Analysis of the BFO value can provide information about the relative motion between the satellite and the aircraft. Figure 1 shows all the BFO recordings from 9M-MRO. The comprehensive analysis provided by the Defence Science and Technology (DST) Group ([Bayesian Methods in the Search for MH370](#)) indicated that the aircraft was likely on a southerly heading at 18:39. From that point until 00:11, all the solutions of the analysis showed a continuing southerly track.

***This graph illustrates the measured BFO recordings throughout the flight with the appropriate error bars on the measurements. After 18:39 the BFO values follow an approximately linear trend until the final two values at 00:19.***

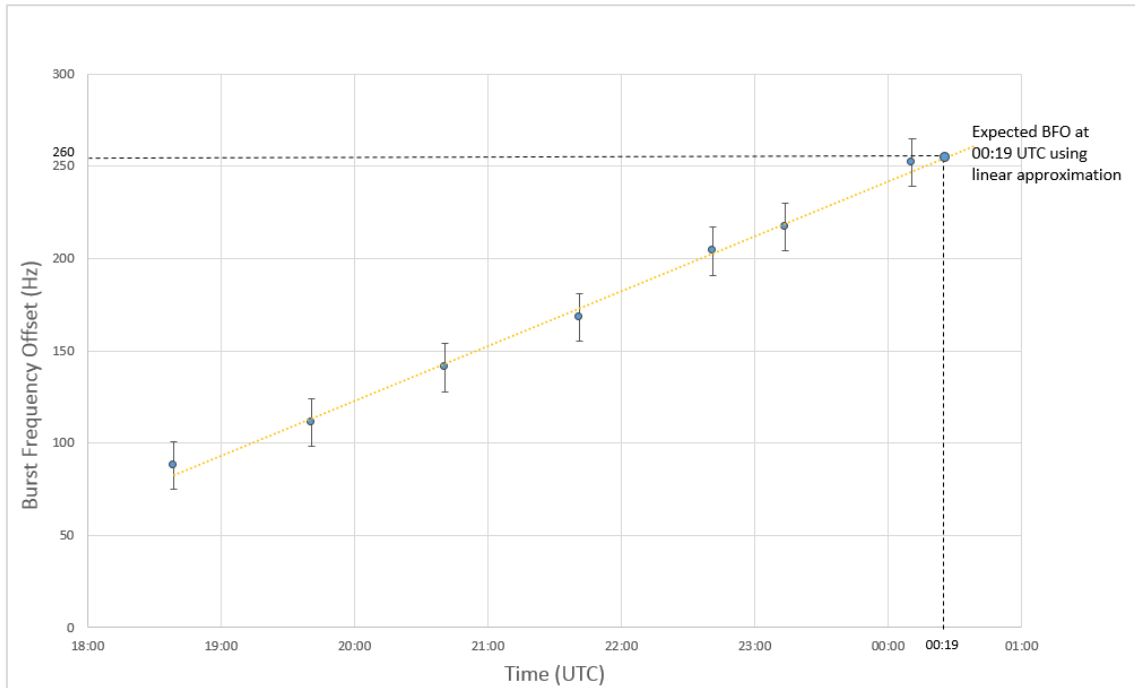
**Figure 2: Linear approximation of the BFO values between 18:39 and 00:11**

The trend of the BFO values from 18:39 until the 6<sup>th</sup> arc (00:11) is due to the change in location of the aircraft and can be linearly approximated (Figure 2). If this linear approximation is extrapolated to 00:19, and if neither the Satcom system nor the aircraft flight path were altered after 00:11, a BFO value of approximately 260 Hz would have been expected.

***This graph illustrates 5 BFO values recorded between 18:39 and 00:11 and the linear approximation of the BFO at 00:19. The first 5 values correspond to the 2<sup>nd</sup>-6<sup>th</sup> arcs. During this time the aircraft is likely to be following a relatively constant southerly track. Continuing this linear trend to 00:19, a value of 260 Hz would be expected.***

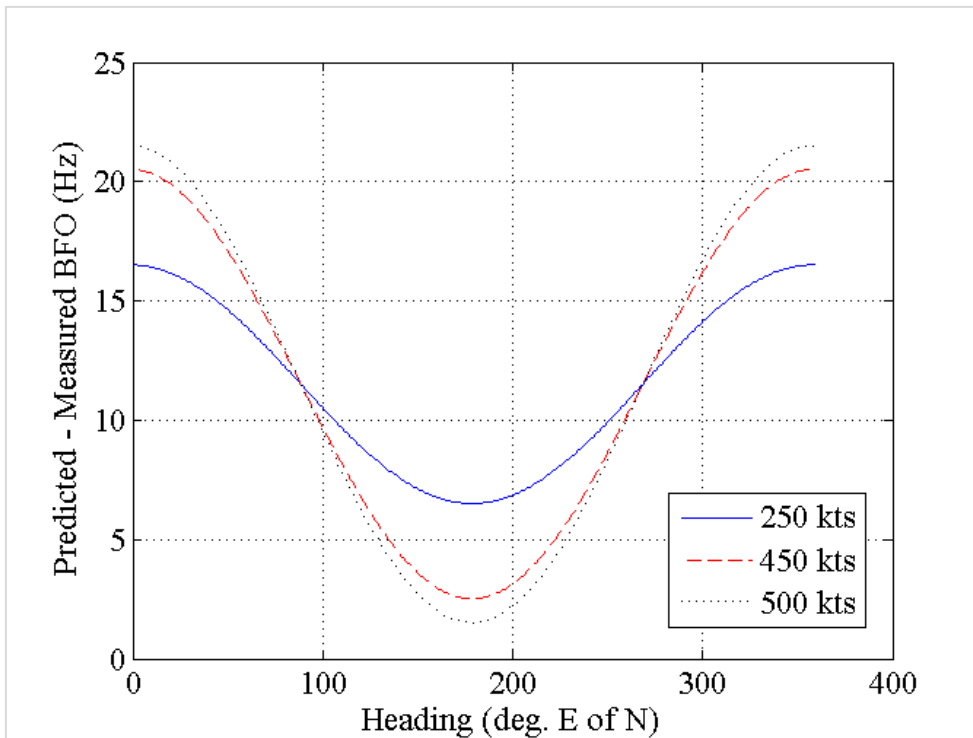
**Figure 3: Variation in estimated BFO differences at 00:19 for given track angles and groundspeed**

For any given speed, the estimated BFO differences can be plotted against the predicted heading of the aircraft (Figure 3). The maximum variation in the BFO differences based solely on change in direction is approximately 20 Hz.

***This graph indicates that the lowest BFO differences, and therefore the closest to our measured values, would be attained for any given speed by continuing in a southerly direction.***

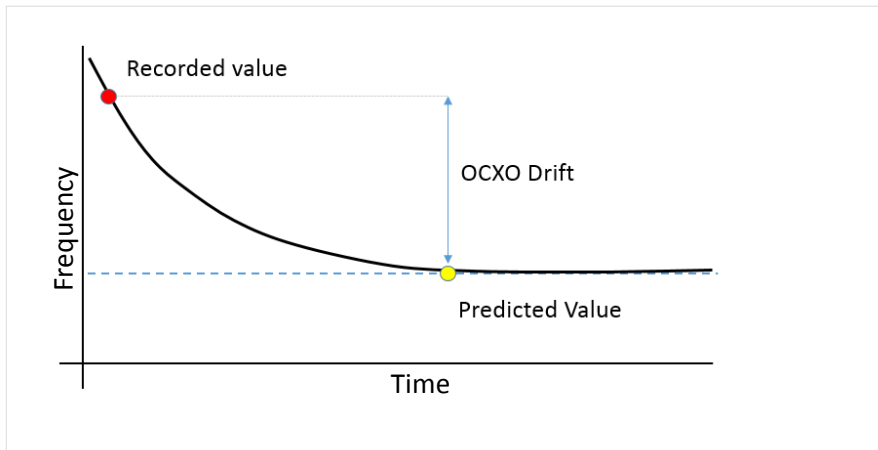
**Figure 4: Representation of 9M-MRO SDU decaying warm-up characteristic (not to scale)**

All available information indicated that, after power-up, the SDU in 9M-MRO exhibited a decay characteristic, represented in Figure 4. The values recorded shortly after power up would therefore be greater than the steady state value.

***This graph illustrates the warm-up characteristic of the 9M-MRO SDU. After power is restored to the SDU, the OCXO drift results in BFO value being above the steady state value until the OCXO has stabilised.***

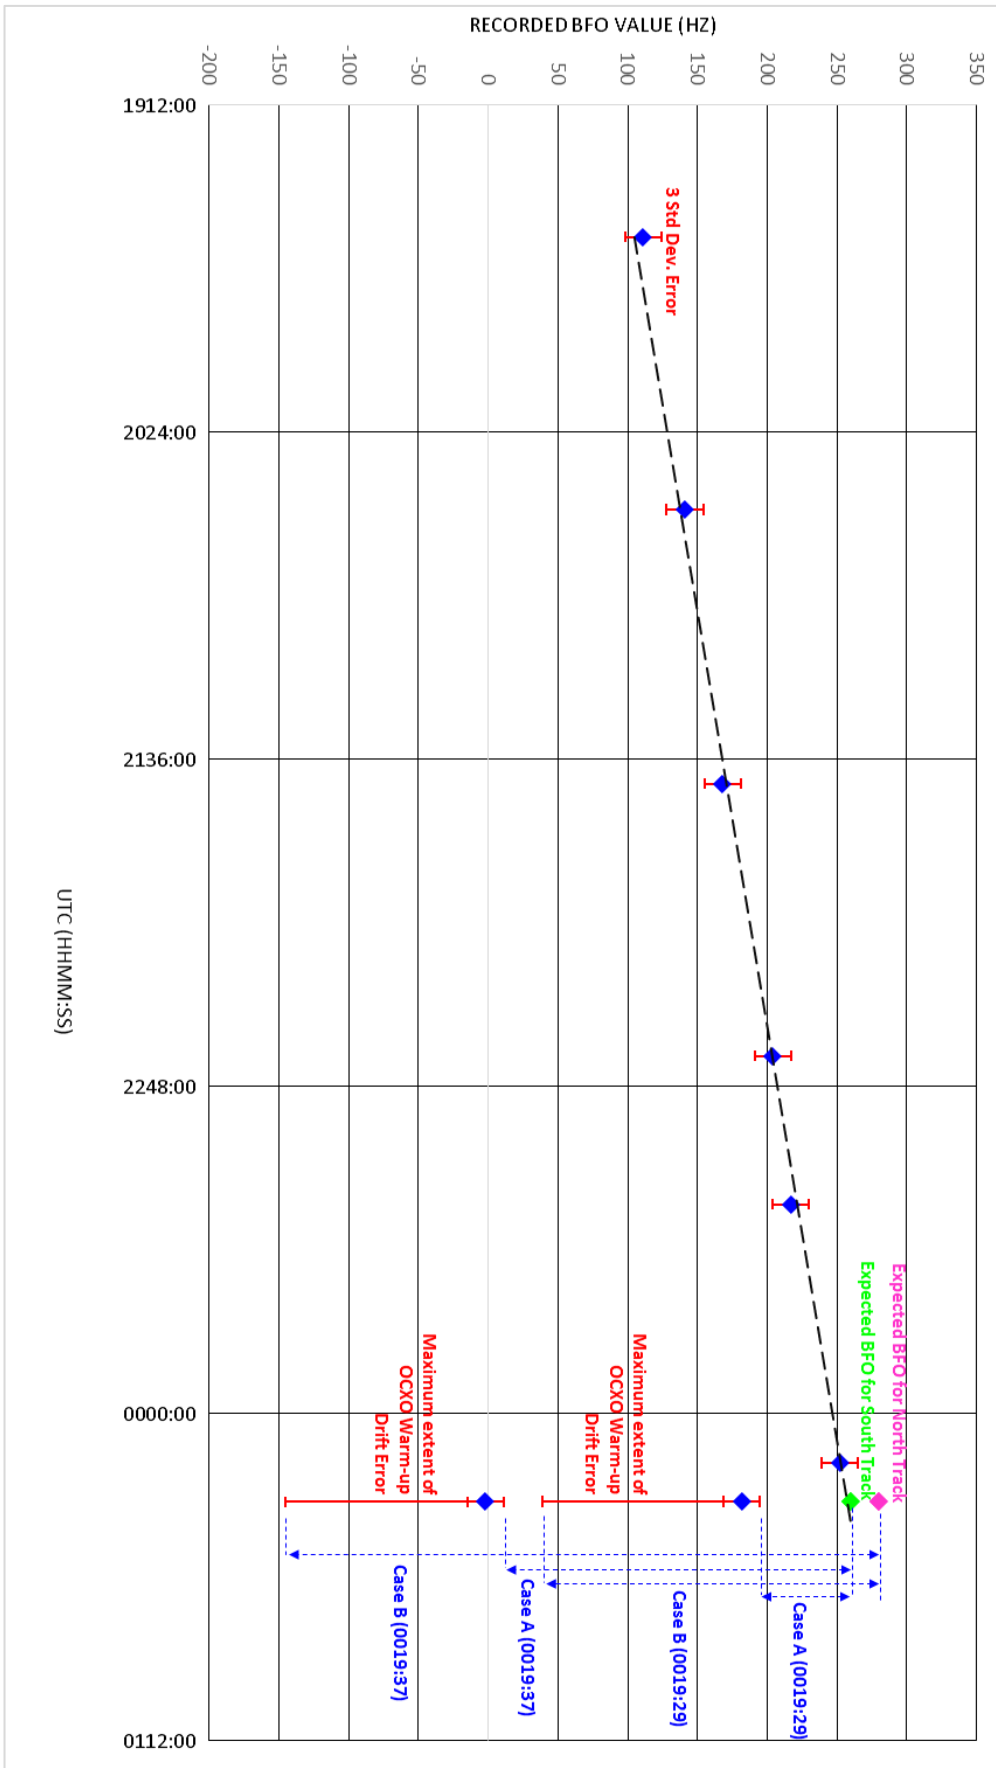
Figure 5: Association of BFO differences to descent at 00:19

Table 2 and Figure 5 following provide the resulting descent rates based on cases above for the log-on request at 00:19:29 and the log-on acknowledge at 00:19:37.

00:19:37 log-on ACK	Case A (minimum)	Case B (maximum)
Predicted BFO level flight	260 Hz	280 Hz
Measured BFO	-2 Hz	-2 Hz
Possible error (3 std dev.)	13 Hz	-13 Hz
OCXO Drift	0 Hz	130 Hz
Derived descent rate	$260 - (-2 + 13) = 249 \text{ Hz}$ $(249 / 1.7) * 100 \approx 14,600 \text{ ft/min}$	$280 - (-2 - 13 - 130) = 425 \text{ Hz}$ $(425 / 1.7) * 100 \approx 25,000 \text{ ft/min}$

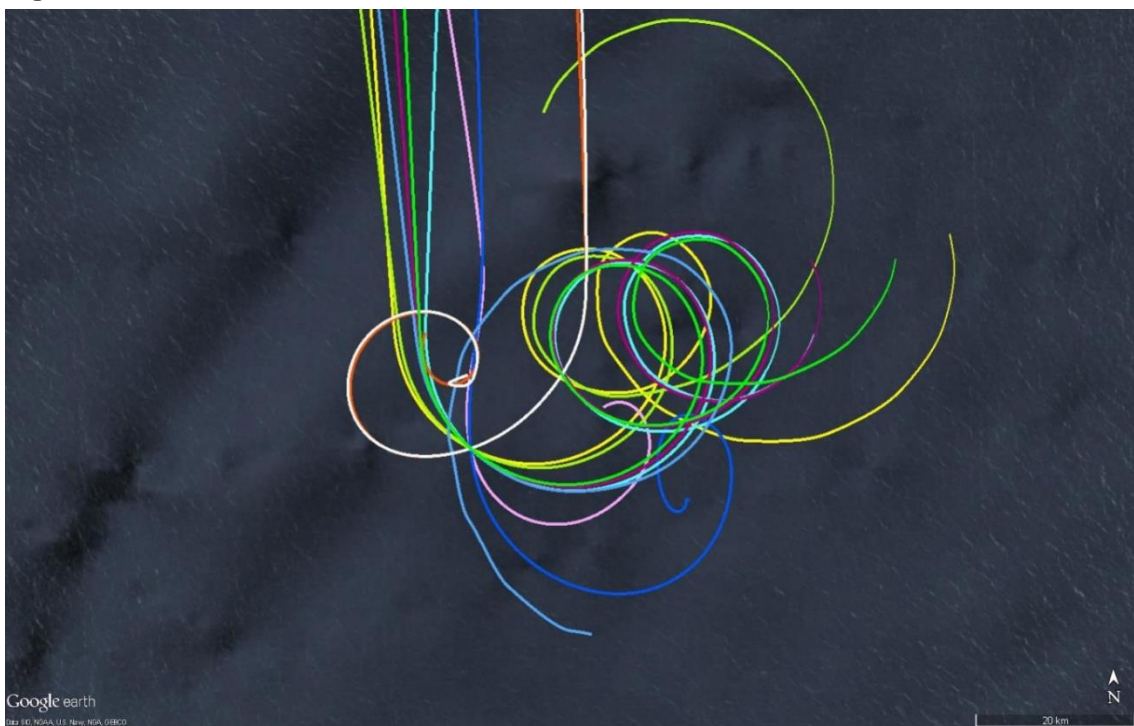
**Figure 6: Results from simulated scenarios**

The results of the simulation are presented in Figure 6. The results have all been aligned to the point two minutes after the loss of power from the engines. This is the theorised time at which the 7<sup>th</sup> arc transmissions would have been sent.

***This figure illustrates the resulting flight paths from the simulations performed by the manufacturer and aligned at a point consistent with when the final BTO transmission may have occurred.***

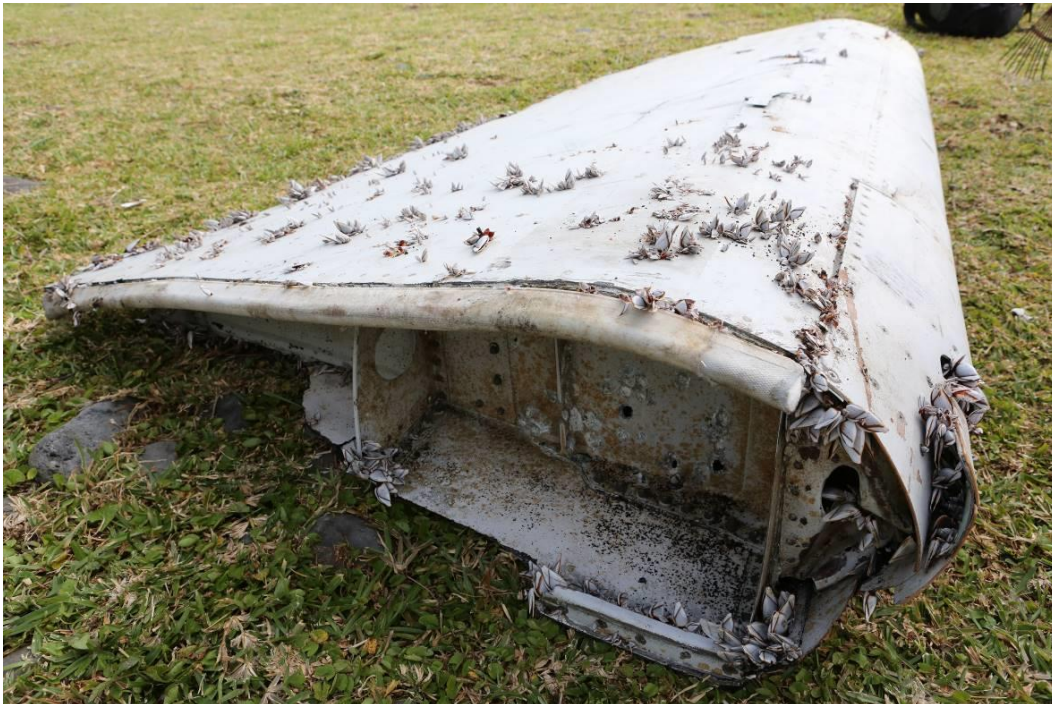
**Figure 7: Flaperon recovered from Reunion Island on 29 July 2015**

As part of the ongoing field testing, the drift behaviour of replica flaperons and other recovered aircraft parts is being assessed. Replica flaperons were constructed with dimensions and buoyancy approximately equal to that of the recovered flaperon (Figure 7), which was float-tested during the detailed examinations in France. The replica flaperons were deployed into a bay for short term tests during various weather conditions. Longer term tests were then performed in the open ocean. For comparison, undrogued drifters were deployed alongside the flaperons. Drogued drifters were also used, because they move predominantly with the currents, as opposed to wind and waves. Data for currents was then able to be subtracted from the flaperons' drift data so that wind and wave behaviour could be assessed in isolation.

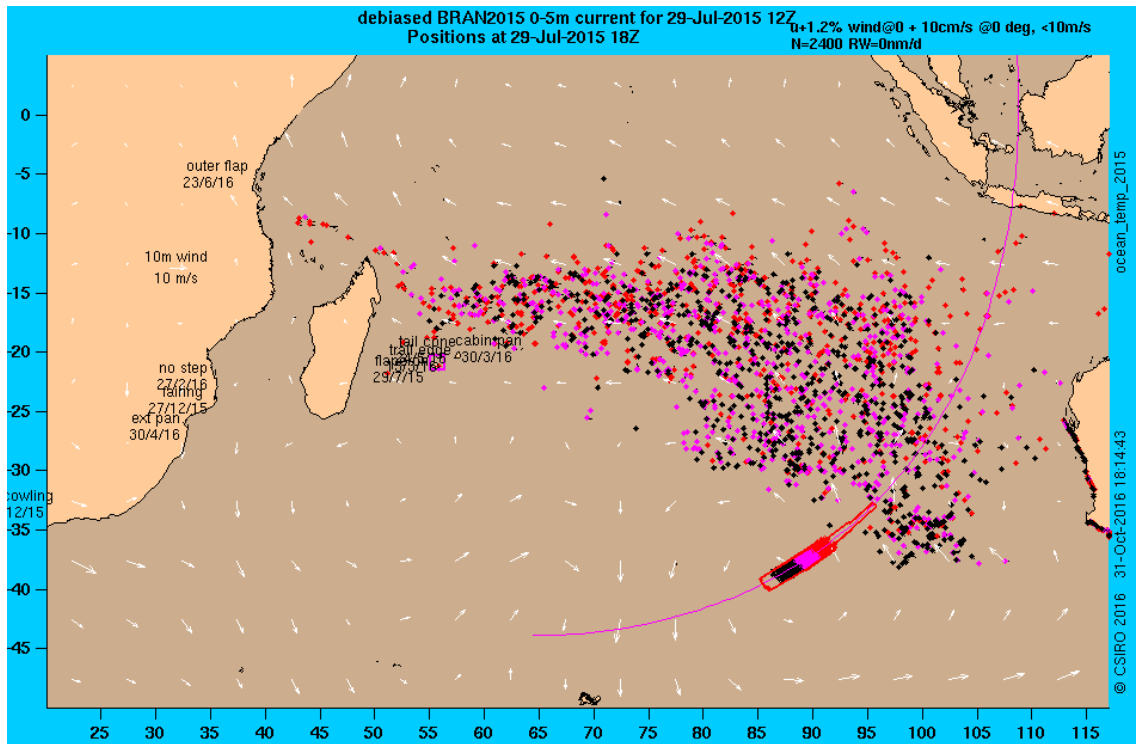
**Figure 8: Simulated location of flaperon-type drifters after 500 days**

Using the collected field data, a new forward-tracking numerical simulation was performed. Within the simulation, flaperons were deployed on and around the current search area and allowed to drift freely. Results after 500 days of simulated drift are presented in Figure 8. For comparison, Figure 9 shows the results of a simulation where the original undrogued drifter model was used. By comparing the two figures, it can be seen that the flaperons generally moved further west within 500 days due to the extra speed at low winds.

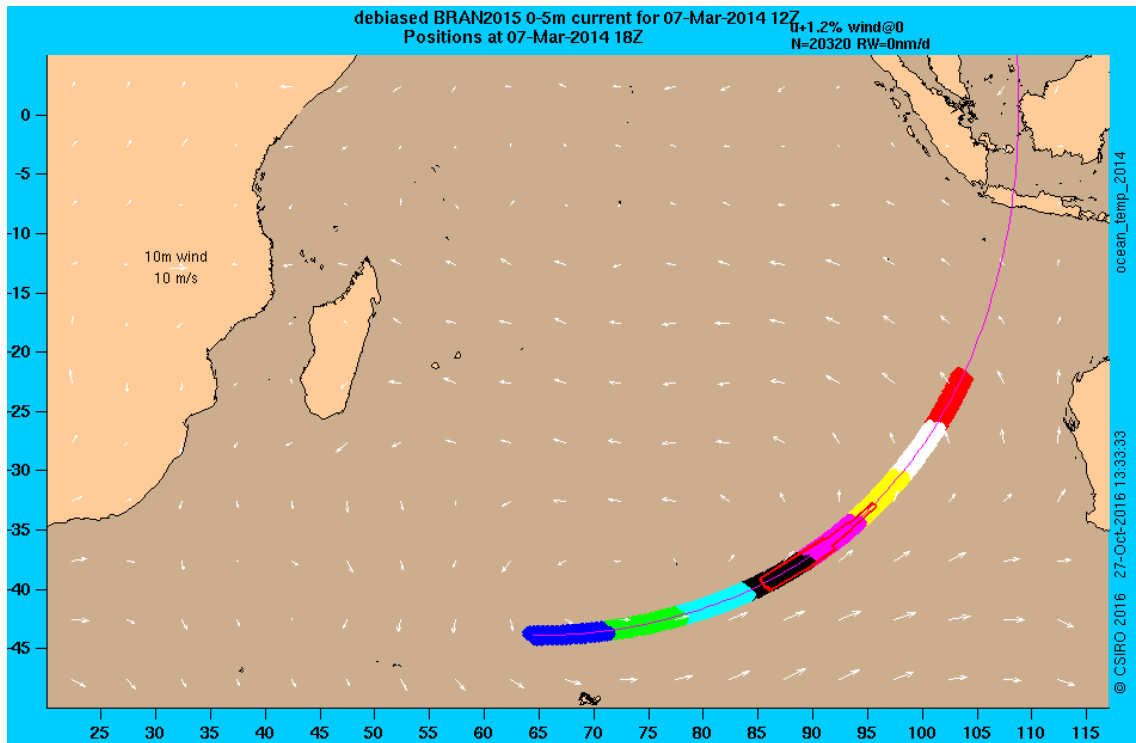
Figure 10: Simulated starting location of undrogued drifters

Figure 10 illustrates the starting location of the simulated drifters along the 7<sup>th</sup> arc. After eight months of simulated drift (Figure 11), some initial conclusions can be drawn about the drifter's path with respect to debris discovered to date. A significant number of drifters arrived on the coast of Western Australia. Similarly, a number of drifters had arrived on the coast of Africa. The colour of each drifter identifies its starting location as marked along the arc.

- Drifters starting in the southern half of the current search area or below (dark blue, green, light blue) can be observed on and around the coast of Western Australia, with many drifting towards Tasmania. No debris has been discovered on the Australian coast. This indicates that a starting location within the current search area, or further north, is more likely.
- A significant number of red drifters have already reached the coast of Madagascar and mainland Africa. This is not consistent with the time at which debris was discovered. The first item of debris was not discovered on Reunion Island until 16 months after the accident. This suggests a reduced likelihood of debris originating from the northernmost areas shown in Figure 10 (red and white coloured regions).

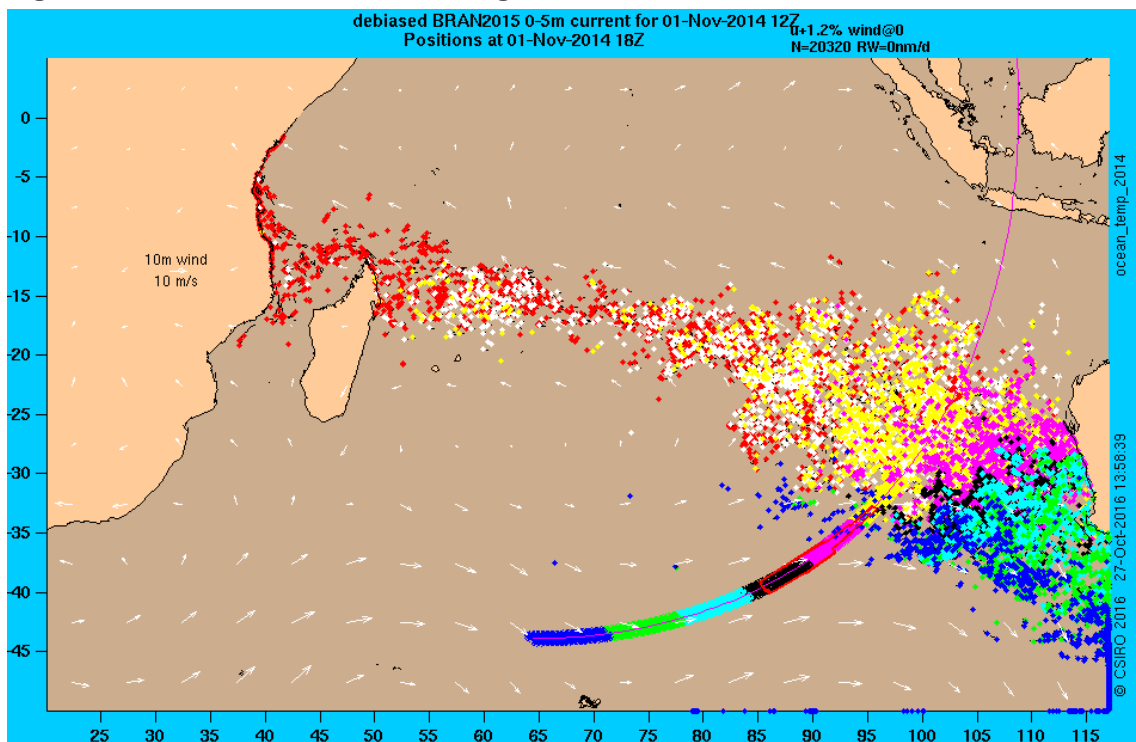
Figure 11: Simulated location of undrogued drifters after 8 months

*A significant number of drifters from the light blue and green areas have made landfall on the West Australian coast. Similarly, drifters from the red and white areas have begun to make landfall on the African coastline. Neither are consistent with times and/or locations at which MH370 debris was discovered, therefore reducing the likelihood of debris originating from these locations.*

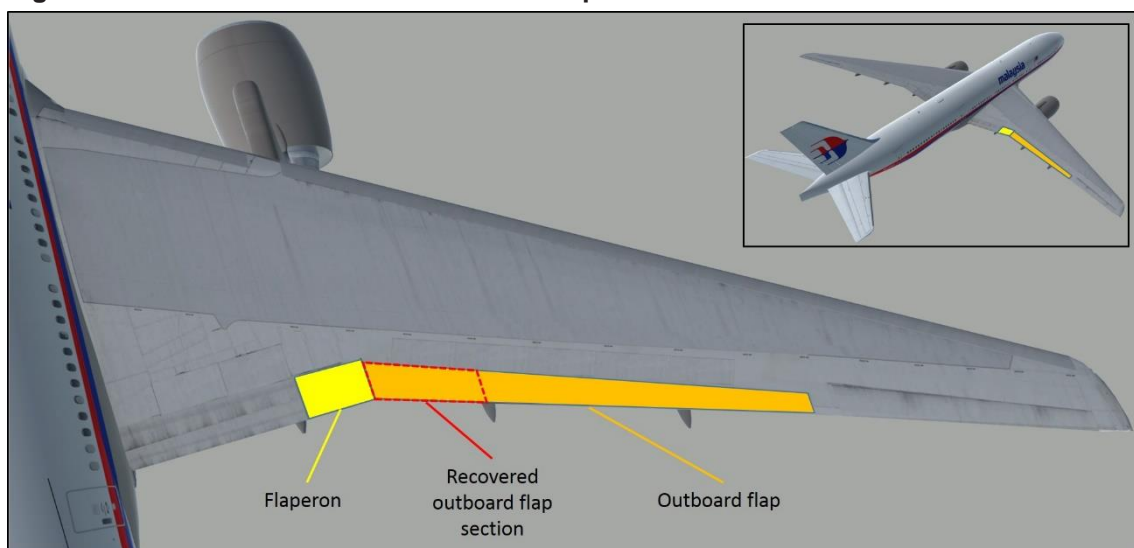
**Figure 12: Location of recovered outboard flap section**

The recovered right, outboard wing flap section (Figures 12, 13 and 14) was examined for any evidence of interaction with mechanisms, supports and surrounding components that may indicate the state of flap operation at the time of fracture and separation from the wing. The purpose of the examination was to inform the end-of-flight scenarios being considered by the search team. The most significant items of evidence in relation to this are documented below.

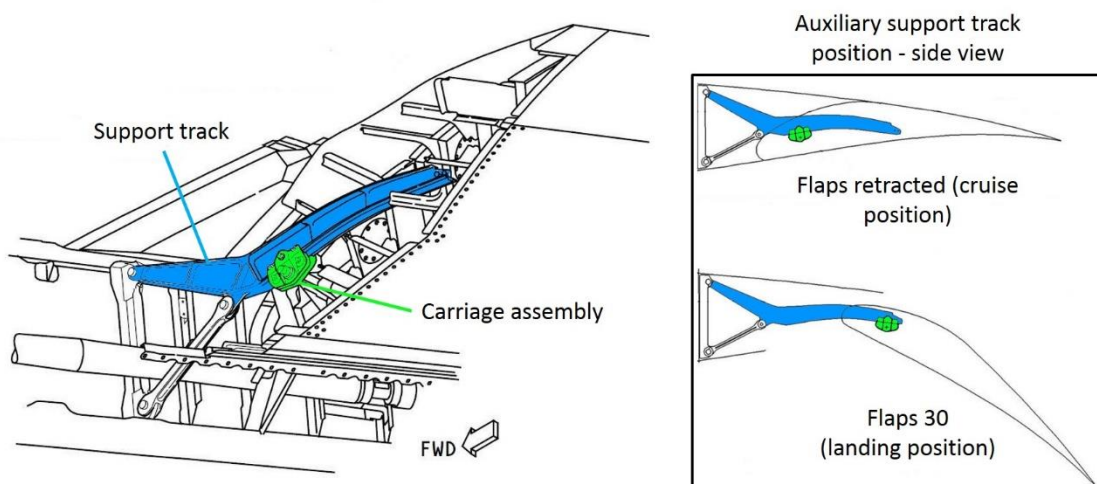
**Figure 15: Outboard flap, inboard auxiliary support**

A fibreglass and aluminium seal pan is located at the inboard end of the outboard flap. It houses the inboard auxiliary support, comprising a deflection control track (support track) and carriage assembly. The support track is affixed to the rear of the wing. Using rollers in the carriage assembly, the inboard end of the flap is guided along the support track as the flap moves through its deflection range. The track is fully inserted into the flap in the 'up' position and progressively withdrawn from the flap as the flaps are deployed (Figure 15). The inboard auxiliary support track and carriage assembly were not present with the recovered debris.
